Molonglo Catchment Health indications Report,

January to June 2013

Stephen Skinner

Waterwatch Coordinator, Molonglo Catchment Group

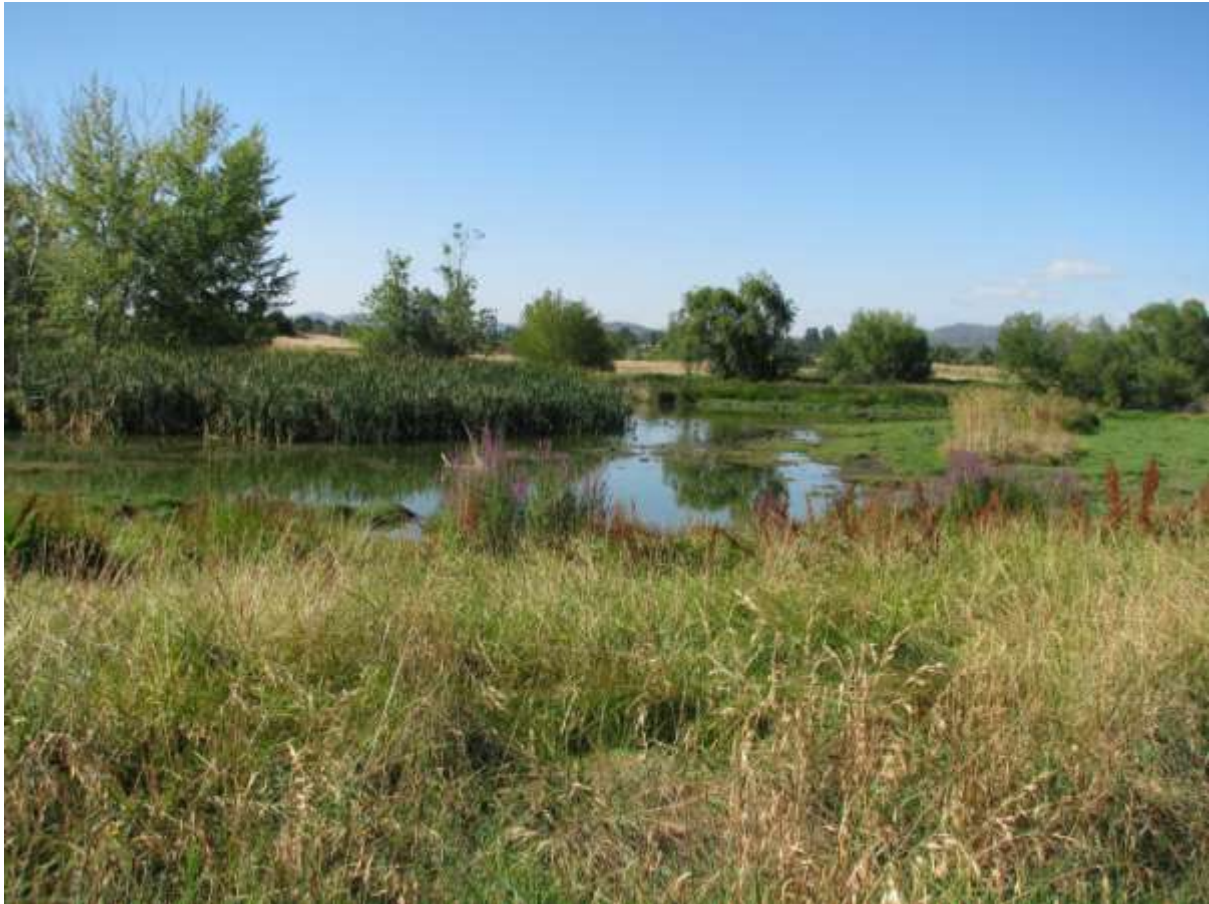
Kelly's Swamp, from the Ardea hide, January 2013.

Although Kelly's Swamp was dry from the end of January, the creek reported a CHiP score of 2.3, indicating Good Catchment Health.
