The Molonglo Catchment Health indicator

Program Report

July to December, 2009.

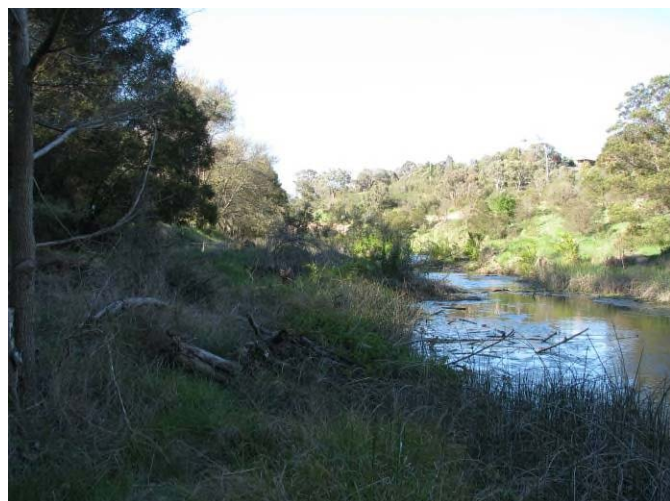
Figure 2: The Queanbeyan River at Dane St, looking down stream and across to Dodsworth (QUE460). This area is currently being rehabilitated.

The sub-catchment shows consistently close to standard water conditions and has a condition rating of 2.4 well into the **Good** range. This is remarkable for a built-up area.
