## November in our Catchment

### Site Condition and Photo Points

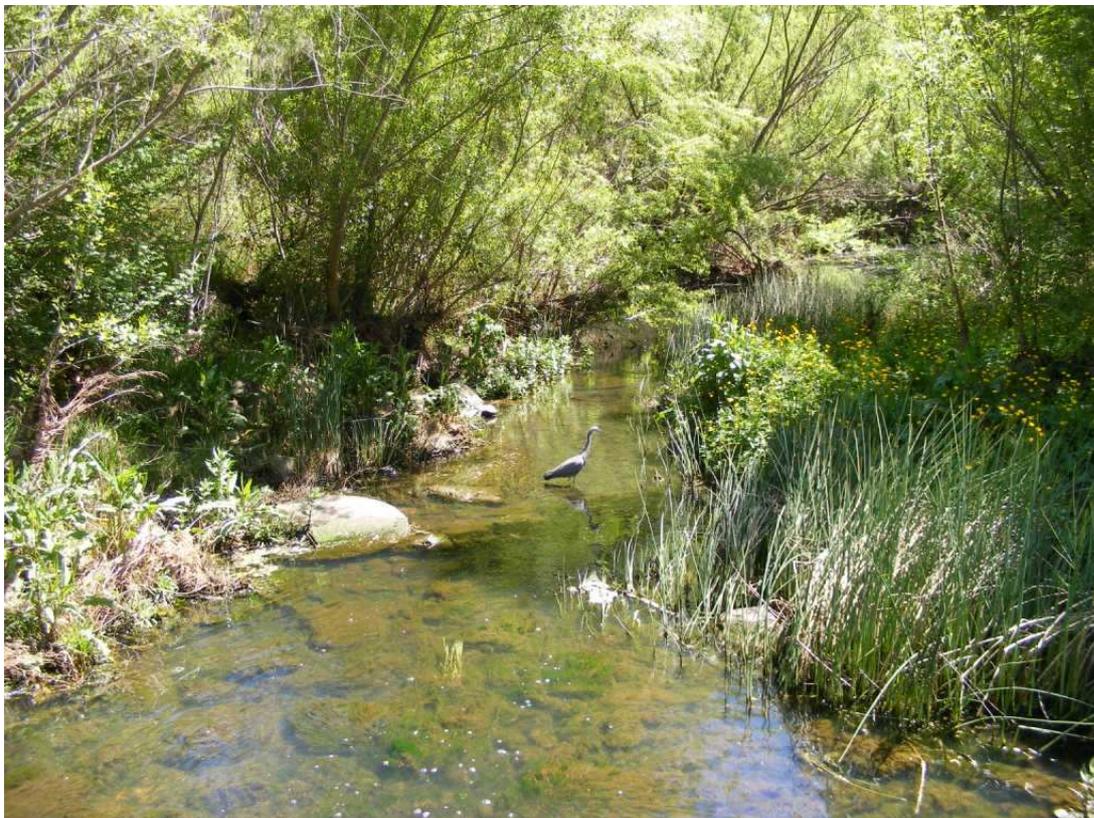
**Figure 1 The Queanbeyan just before she leaves NSW, photo by John Bruggeman**

- The cobbled bottom of the waterway is easily seen.
- So is the cover of algae, where there are streamers of rusty brown diatoms and tufts of bright green *Stigeoclonium* (I'm sorry it doesn't have a common name).
- There are well developed beds of emergent vegetation,
- and both shrub and canopy layers are well developed.

This gives the site plenty of dappled light, to keep the water temperature lowered and the dissolved oxygen retained. So on first inspection the site is in quite good condition.

But... the extent of the algal cover indicates that there are plenty of nutrients available in the system. The emergent vegetation is moderately diverse in structure...some rushes, some leafy annuals...but while the River Rush (*Schoenoplectus validus*) is local, the buttercups may not be and the speedwell and dock almost certainly are exotic. The shrubs look suspiciously like plums and hawthorn, and the trees are willows. The structure is fine, the species are not the most suitable.
