July in our Catchment

Algae at your Site:

Catchment Report:

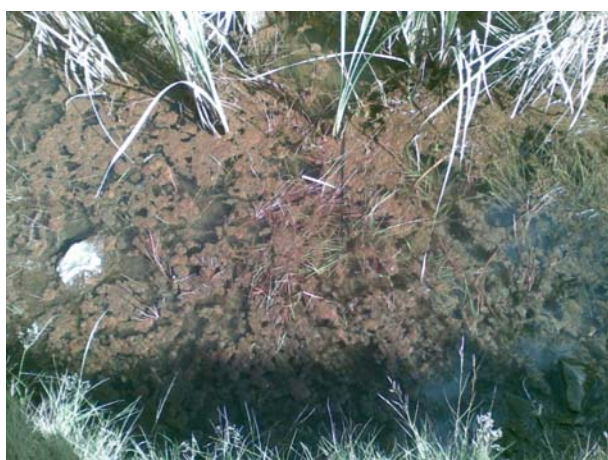
This image of algal scum was sent in by the Hodgman family from near Captains Flat. It shows what scientists call metaphyton floating on the surface at the end of the growing season. There are numerous different organisms in the floating mass, and most are producing spores, so it has the weird rose madder colour. It is actually healthy, as the spores will either dry on the banks, then become dust and get blown far and wide or they will be washed down stream as the pontoon rots and breaks up.

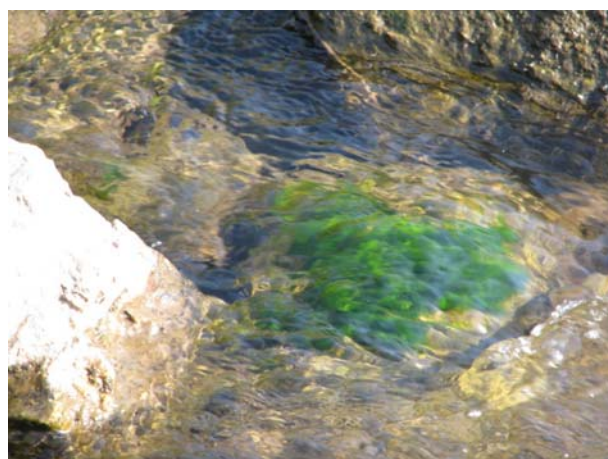
These bright green tufts are clumps of the green alga *Stigeoclonium* and the plant precursor *Klebsormidium* growing together on some sunny cobbles in a riffle in the Queanbeyan River. They are important in winter and spring as they add oxygen to the water and are also the food for several kinds of macroinvertebrates, especially in cold weather. The presence of healthy tufts of these and some related algae can be used to demonstrate that the system is healthy, but that more riparian shrubbery may be needed

on the surrounding banks.

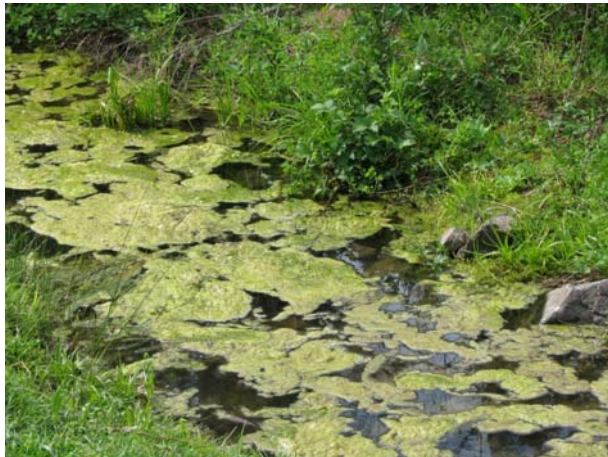
With a flush of nutrients from the catchment after rain the pools in most of our ‘base flow’ creeks, like Stony Creek that flows into the Murrumbidgee near Jews Harp Bend, will rapidly fill with a bloom of filamentous algae. If this is one of the silkweeds it will last a few weeks and go away...nuisance but no problem. If it is one of the blanket weeds it will persist and eventually choke the waterway. The common names describe what the filaments feel like, so they are usually easy to

distinguish. Blanket weed can be a real problem in areas of improved pasture or near crop paddocks.
